NASA Technical Paper 2236

Galvanic Coupling Between D6AC Steel, 6061-T6 Aluminum, Inconel 718, and Graphite-Epoxy Composite Material: Corrosion Occurrence and Prevention

Merlin D. Danford and Ralph H. Higgins

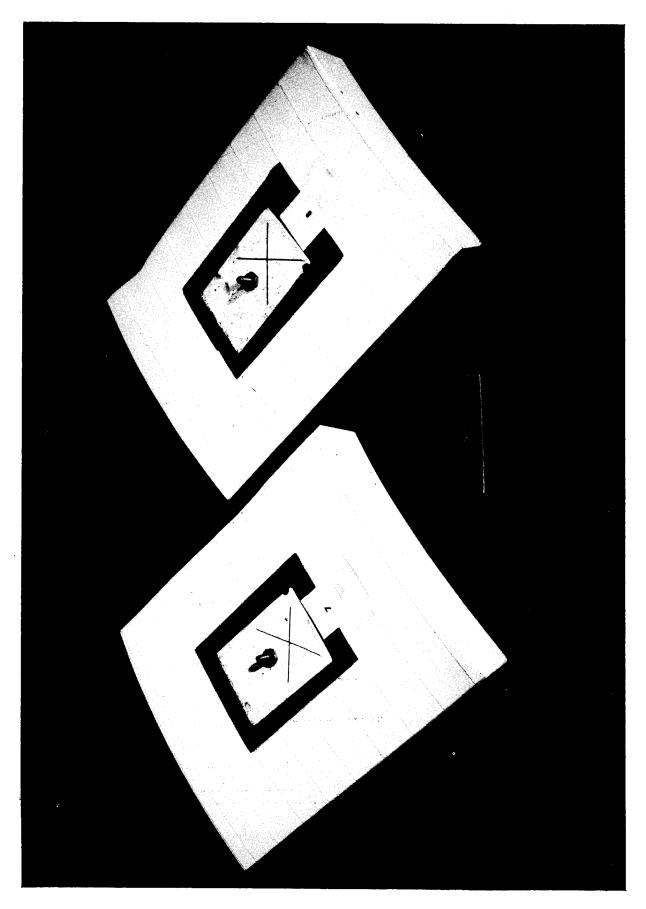
Photographs of the complete assemblies after removal from the 3.5% NaCl solution are shown in Figures 1 and 2 for tests 4 and 5 respectively. For test number 1, both the G/E and D6AC steel plate were in good condition, with no visible sign of rusting on the metal and no rust streaks on the G/E. Specimens 3 and 4, for test number 2, showed heavy rusting at the center of the scribe marks, with other rust spots being evident on the D6AC steel plates. Heavy rust streaks appeared on the G/E surface. For test number 3, small rust spots were evident at one corner of the D6AC steel plates on both specimens 5 and 6, with small rust streaks being evident on the G/E surfaces. In test number 4, a photograph of which is shown in Figure 1, all surfaces appeared in good condition with no rusting evident on the steel plates, numbers 7 and 8. For test number 5, shown in Figure 2, heavy rusting was evident along one scribe mark for steel specimen 9 and in the center of the scribe marks for steel specimen number 10. Heavy rust streaks appeared on the G/E surfaces in both cases. For test number 6, which comprised the test for aluminum samples, all surfaces appeared in good condition, although a small amount of white Al₂O₃ formed in the scribe marks on the aluminum plates. This condition was difficult to determine visually.

Figure 1. Complete assembly for test No. 4 after removal from 3.5% NaCl solution.

The results also indicate that, when the G/E is completely coated, satisfactory protection of the D6AC steel is achieved with either the zinc-rich primer or the primer/topcoat combination, as shown by comparing tests 3 and 4, which had very similar weight losses. This is true despite the small rust spots observed at the corners of the metal plates in test number 3. These may have been caused by sharp corners on the metal plates.

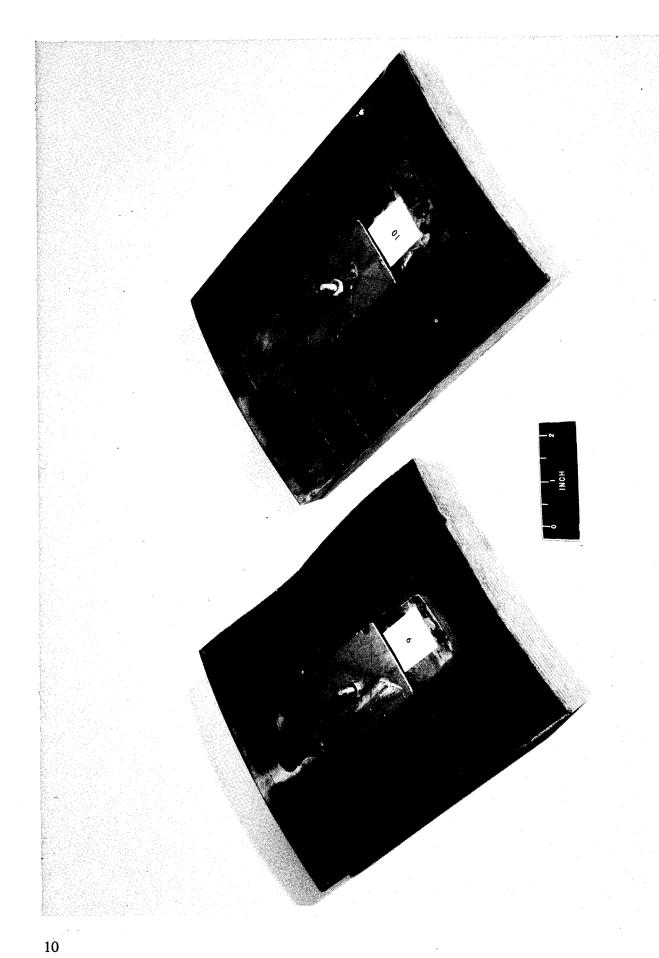
occurred at the scribe marks in the metal surfaces, where only Conoco grease served to protect the bare metal. The remainder of the metal surfaces, which were coated with zinc-rich primer and Conoco grease, appeared to be in relatively good condition. The same situation was present in test number 5, where the total G/E surfaces were left bare.

Figure 2. Complete assembly for test No. 5 after removal from 3.5% NaCl solution.

From the experimental results obtained, it is evident that the surfaces of the G/E must be completely coated, either with topcoat or a combination of polyurethane resin and topcoat. In test number 2, where only a polyurethane joint was employed with the remainder of the G/E surface left bare, heavy corrosion

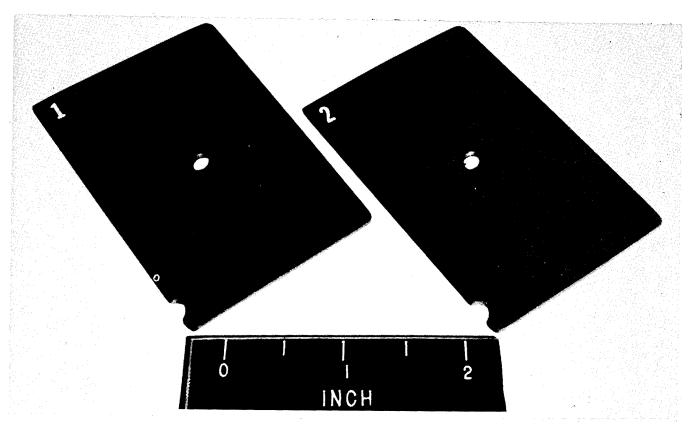
Paint was stripped from all metal samples after disassembly with Cee-Bee A-202 epoxy and polyurethane stripper, after which they were cleaned according to procedures described in ASTM G1-72 and weighed to determine weight loss. Photographs are shown in Figures 3 through 8 for the metal specimens in tests 1 through 6. Weight losses for each specimen are listed in Table 5, along with the average weight loss obtained in each test. For test number 1, the average weight loss was 32.1 mg, a rather small value, with the cleaned surfaces being in good condition. For test number 2, specimen number 3 exhibited a circular pit approximately 6 mm in diameter with corrosion all the way through the metal. The weight loss in this case was 246.7 mg. Specimen number 4 displayed a large oblong pit approximately 5 by 10 mm at the surface corroded to a depth of 1 mm. Weight loss for this case was 459.2 mg. The average weight loss for test number 2 was 353.0 mg. Specimens 5 and 6 for test number 3 had exhibited small rust spots at the corners. but the metal appeared in good condition after stripping and cleaning. This test showed an average weight loss of only 17.0 mg. For test number 4, where a topcoat had been applied over the zinc-rich primer, specimens 7 and 8 displayed an average weight loss of only 12.9 mg and appeared in very good condition. For test number 5, where the G/E surfaces had been left completely bare heavy corrosion occurred on both specimens. Specimen 9 displayed two large pits along one scribe mark. One of the pits was approximately 3 by 5 mm at the surface and had corroded to a depth of 1.5 mm. The other pit measured 5 by 7 mm at the surface and had corroded to a depth of 0.5 mm. Specimen number 10 exhibited a circular pit approximately 8 mm in diameter which had corroded all the way through the metal. Weight loss for these specimens averaged 389.4 mg. For test number 6, which involved the aluminum specimens and G/E completely covered with topcoat, the aluminum samples appeared in very good condition after cleaning, and exhibited an average weight loss of only 12,3 mg.

Figure 3. Metal specimens for test No. 1 after exposure and cleaning.

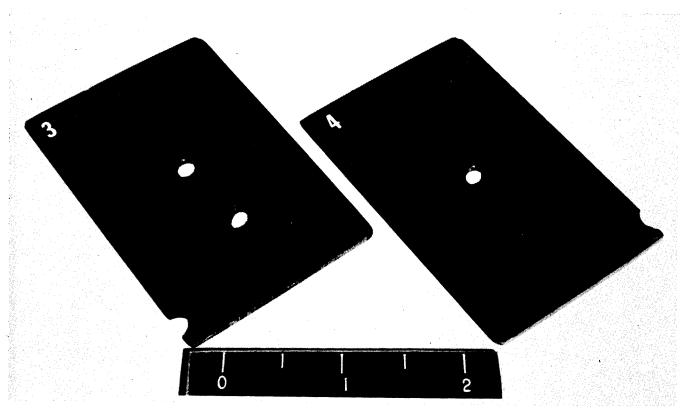
Figure 4. Metal specimens for test No. 2 after exposure and cleaning.

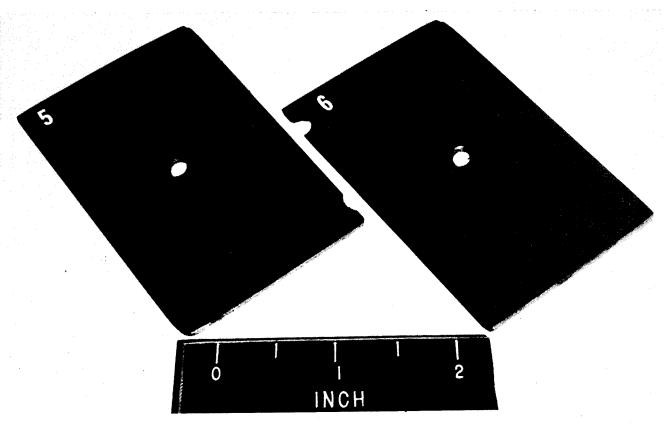
Figure 5. Metal specimens for test No. 3 after exposure and cleaning.

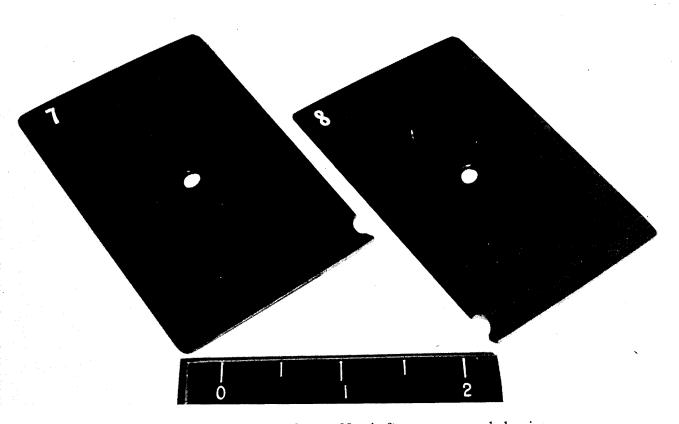
Figure 6. Metal specimens for test No. 4 after exposure and cleaning.

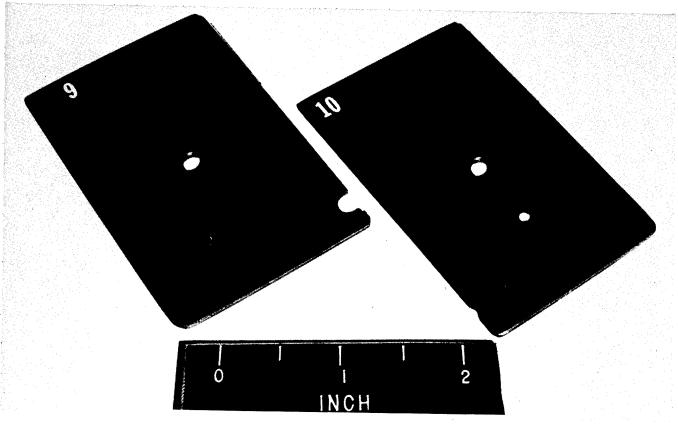
Figure 7. Metal specimens for test No. 5 after exposure and cleaning.

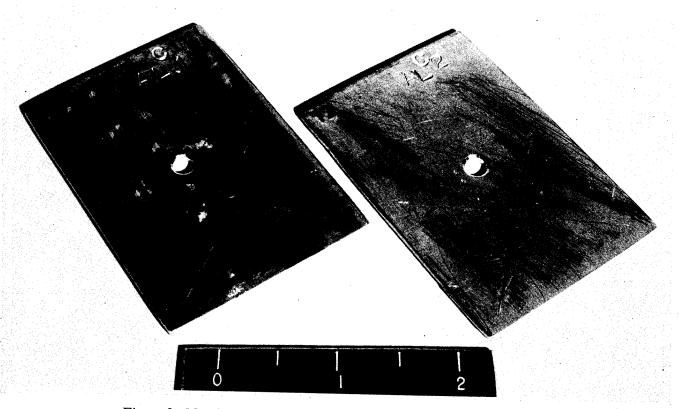
For the case of aluminum in test number 6, the condition of the aluminum was very good and the weight loss was rather small. Although Conoco grease was used as a final coat for the aluminum plates, it is likely that equally good results would have been obtained without Conoco grease.

Figure 8. Metal specimens for test No. 6 after exposure and cleaning.
